Case Study: Seamless Flooring Systems

Safety Markings for Leading Car Parts Manufacturer

Project: Installation of safety markings adjacent to inspection pit

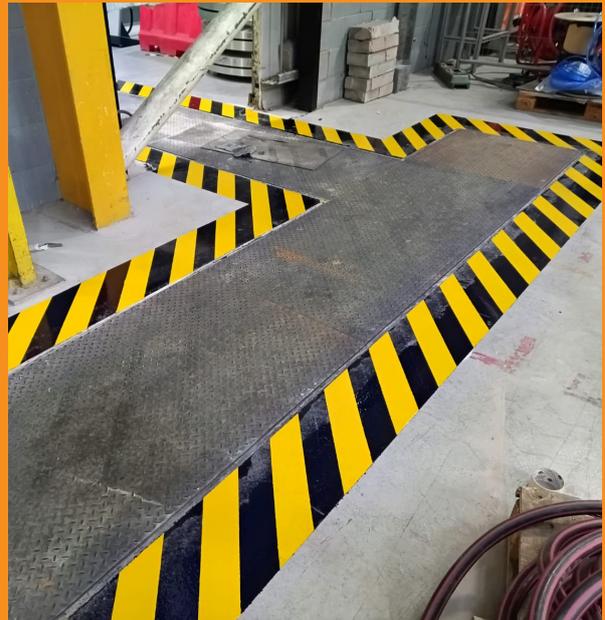
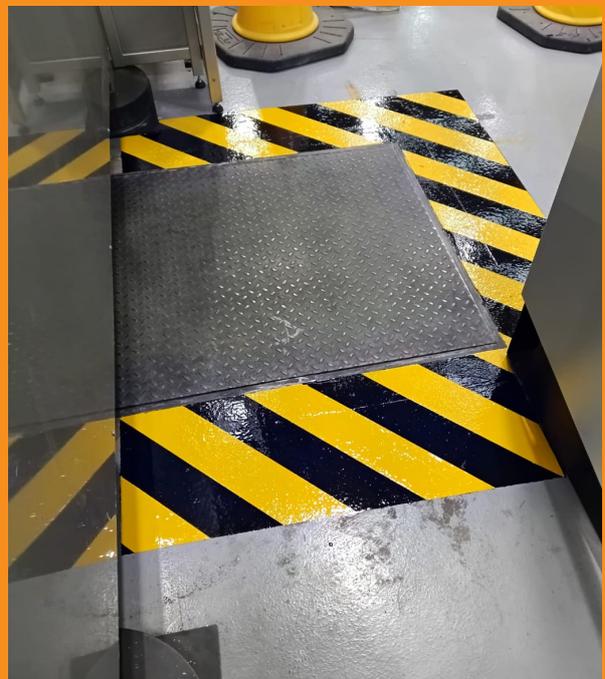
A leading Midlands car parts manufacturer identified a potential safety risk adjacent to conveyor belt covers that can be removed to allow maintenance access to an inspection pit.

Although the existing steel plates were fully compliant with structural standards, the surrounding edges lacked high-visibility markings. In a busy production environment, this increased the risk of trips and falls when covers were removed or repositioned.

Following an initial assessment, Zenith Contract Services prepared the existing substrate using orbital grinding to ensure a clean, properly profiled surface for coating adhesion.

A 100mm wide diagonal stripe pattern was carefully measured and marked out before being fully masked to ensure precise alignment and crisp definition. A high-build epoxy resin coating was then applied in two coats using safety-compliant yellow and black.

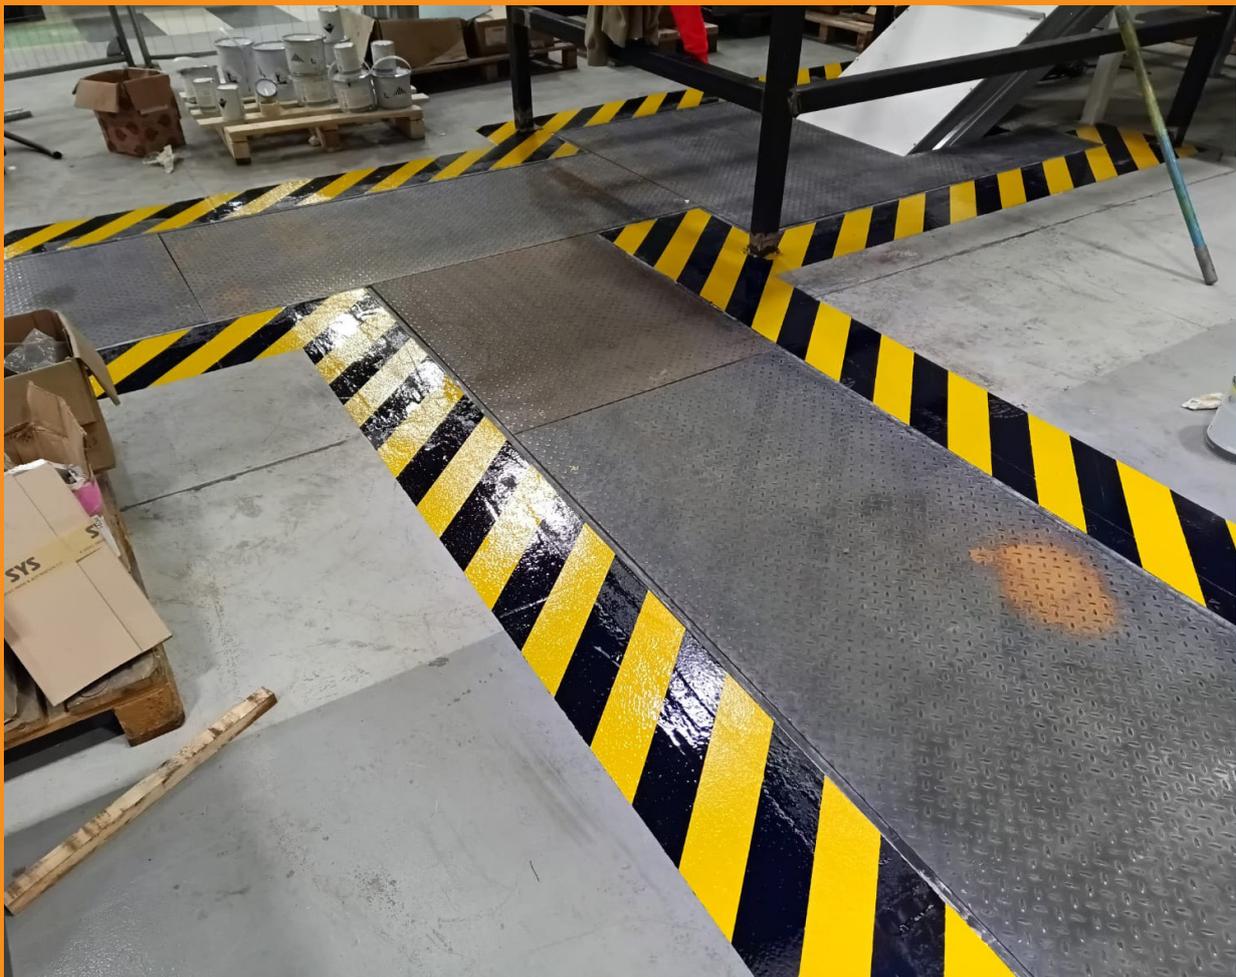
The completed installation provides clear visual hazard distinction adjacent to the inspection pit and maintenance access covers. The high-visibility markings significantly improve on-site safety awareness while maintaining a clean and professional finish.
