Case Study: Resin Flooring

Accident Repair Centre

Client: Accident Repair Centre

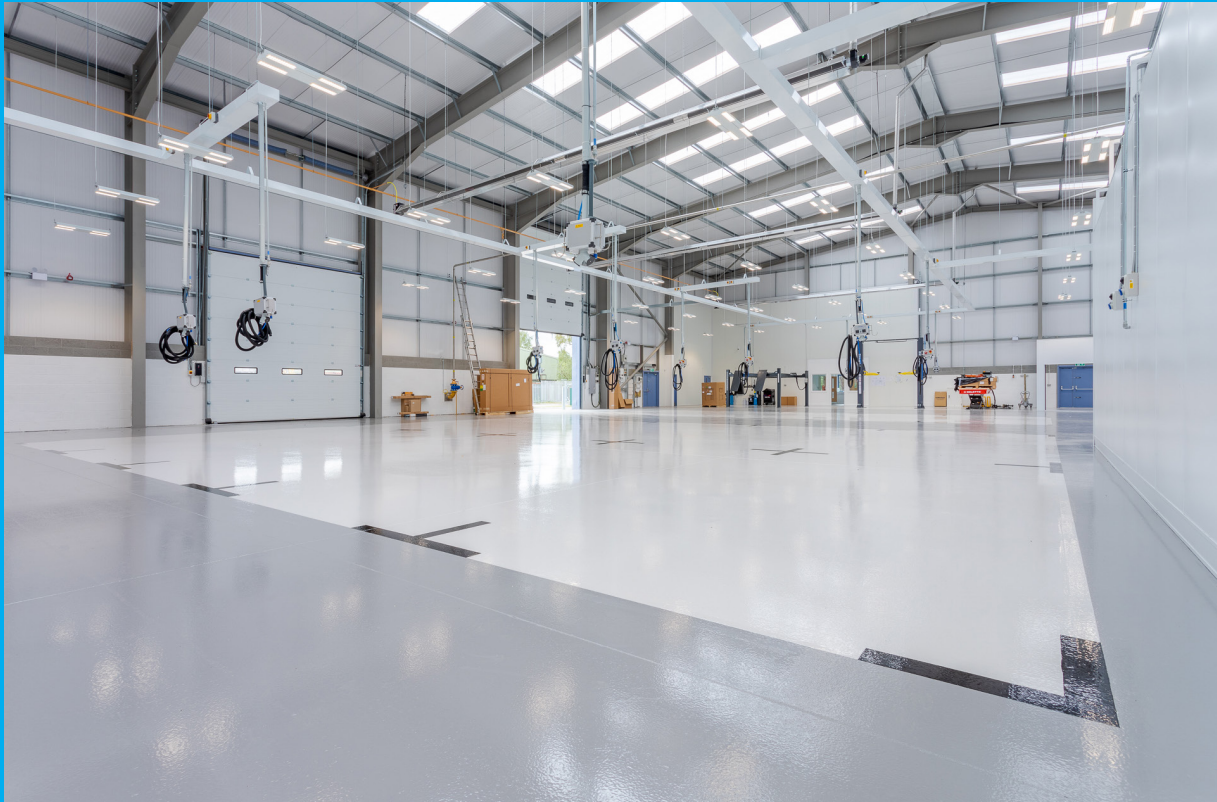
The floor area was then measured out, and a demarcation phase was completed to distinguish areas within the floor - a multi coloured system was used to create walkways and running aisles within the floor. Once the coloured resin had been applied black 'T'

pieces were marked out to denote the parking bays. This process required high levels of accuracy and precision to match the layout provided in the drawings.

The initial stage of preparation included mechanical shot blasting under vacuum extraction to provide a suitable mechanical key for the FeRFA type 3 resin coating that had been specified.
