Case Study: Seamless Flooring Systems

Hospital Pot Wash Area Refurbishment

Client: Alexandra Hospital

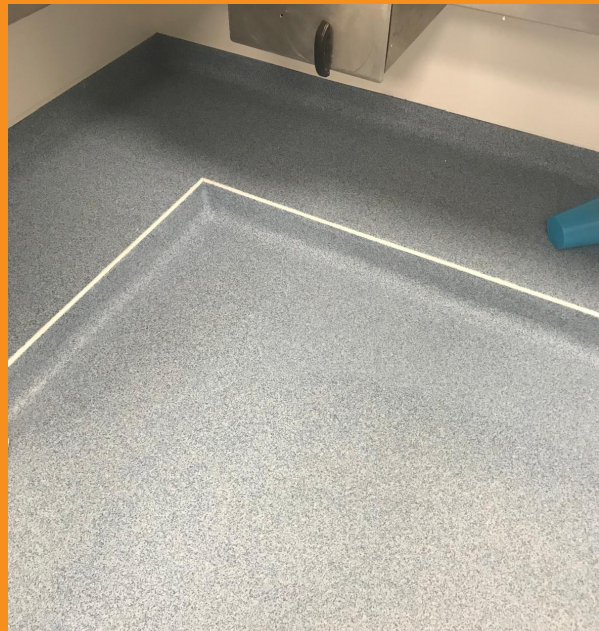
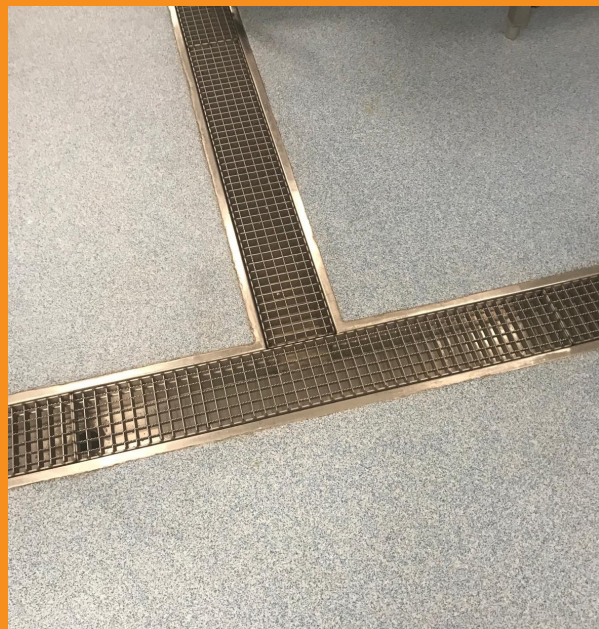
With the old flooring removed, the exposed floor was prepared to receive two coats of epoxy resin primer. To provide reinforcement and reduce the risk of subsequent cracking, a fibreglass mesh was introduced into the primer.
