Case Study: Zenith Refitment

Zenith gives Covpress building a new lease of life

Client: Covpress

Project: Painting & Decorating

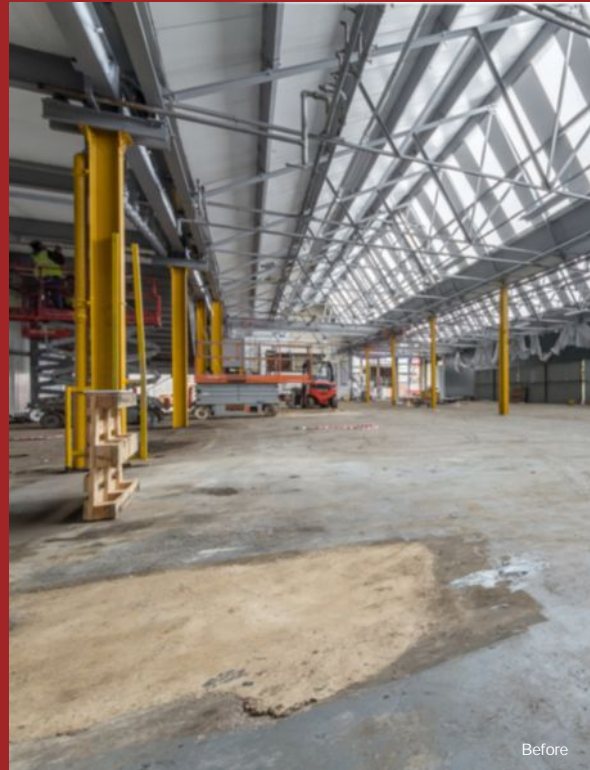
Before

Zenith Refitment Services was contracted to handle painting and decorating of the former Coventry Radiator and Presswork Company Limited premises, which is over sixty years old and has not been decorated since the 1970s. The project involves three separate stages and is currently nearing completion ready to be operational in May 2016.

The first stage involved preparation of the roof steel works, requiring many layers of old paint and excessive rust build up to be removed before a rust inhibiting Zinc Phosphate Primer could be applied, followed by an oil-based eggshell paint.

The second stage involved floor preparation, with teams using mechanical grinding machines to clean and provide a suitable surface to which heavy duty paint could adhere. Leyland Heavy Duty Floor Paint was applied, which is resistant to chemicals, water, oil and grease and ideal for use on concrete floors.
