Case Study: Seamless Flooring Systems

Sweet Flooring Solution For Ice Cream Producer

Project: Major floor repairs to production area

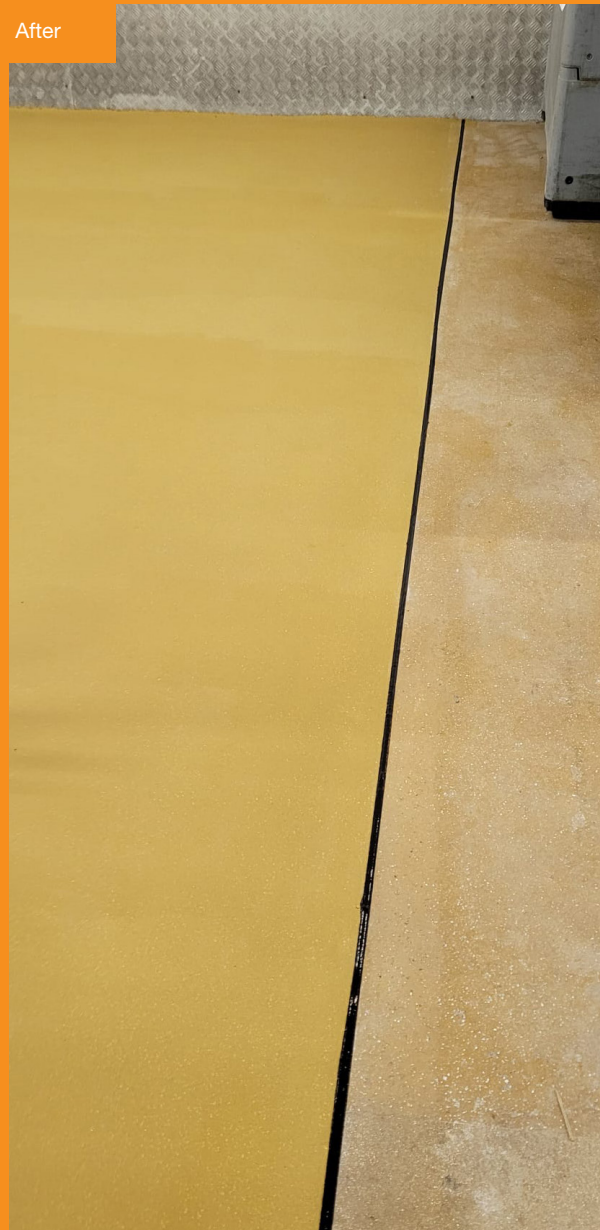
After

The area was then topped with Pumadur HF polyurethane screed, meticulously matched to the existing profiles in a Buff colour. This careful selection ensured seamless integration with the surrounding flooring, creating a cohesive and aesthetically pleasing appearance.

Finally, we introduced a joint at the perimeter where the new and existing floors meet, filling it with Pumexpand jointing compound. This detail not only provided a perfect match but also ensured a seamless transition between surfaces, enhancing both functionality and safety.

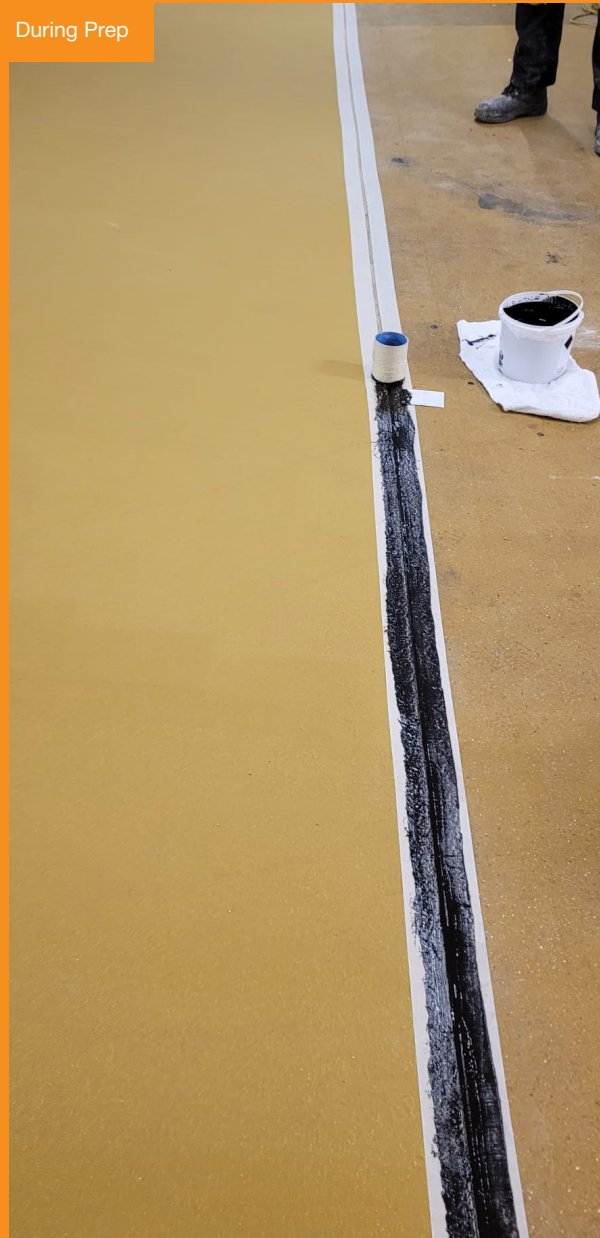
During Prep

The first step involved breaking out the existing ceramic tiles and subfloor. Using heavy breakers, our skilled team carefully saw-cut the area to create neat and defined edges, leaving a rebate approximately 70mm deep to expose the structural concrete beneath. This meticulous preparation laid the groundwork for the subsequent phases of the project

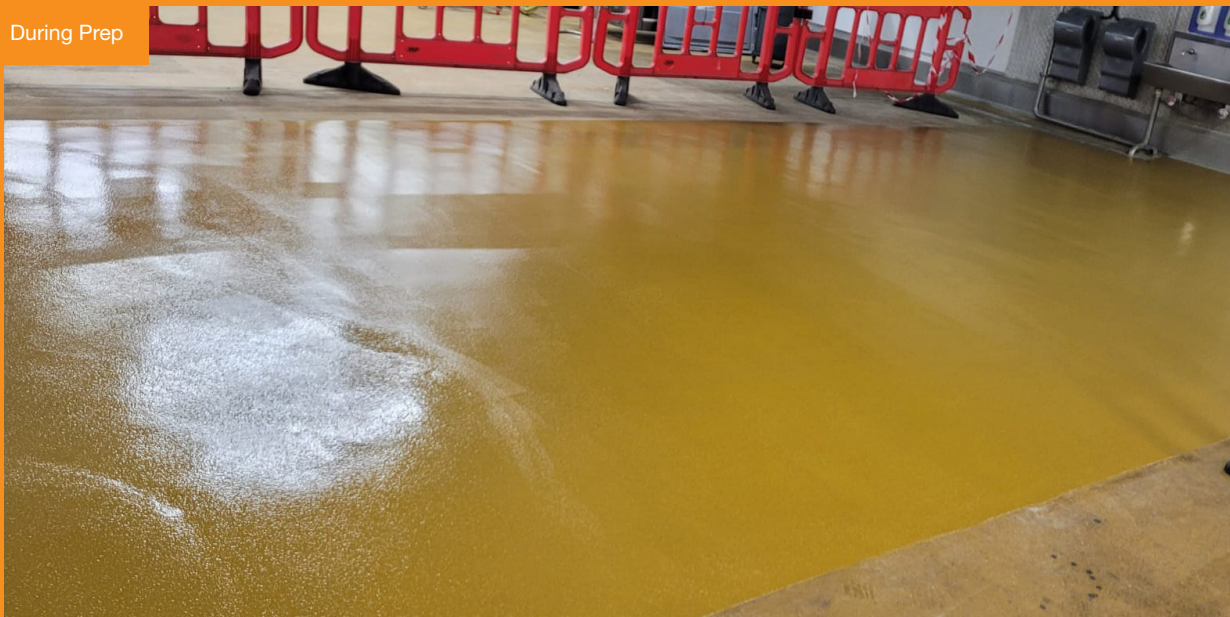
During Prep

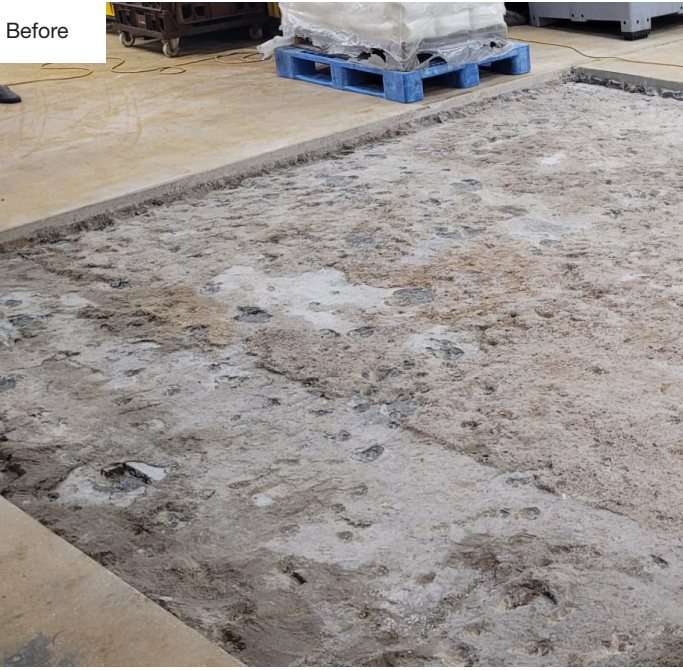
Before

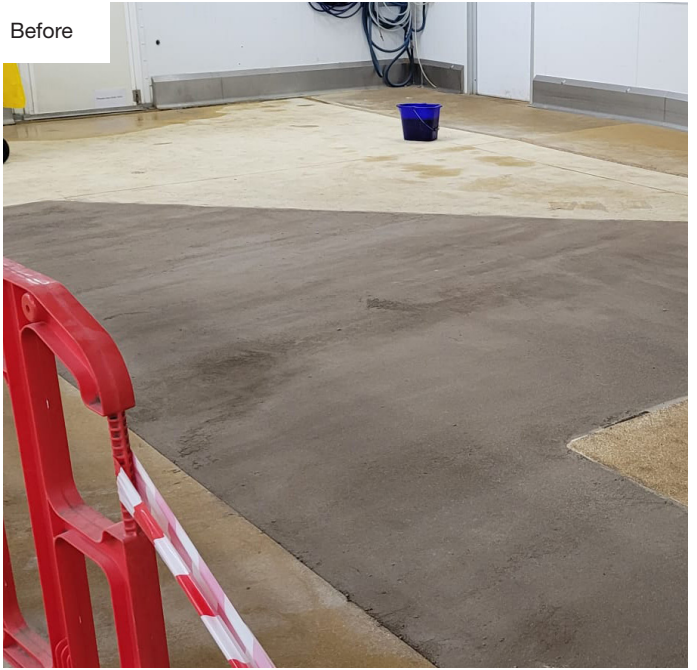
Before

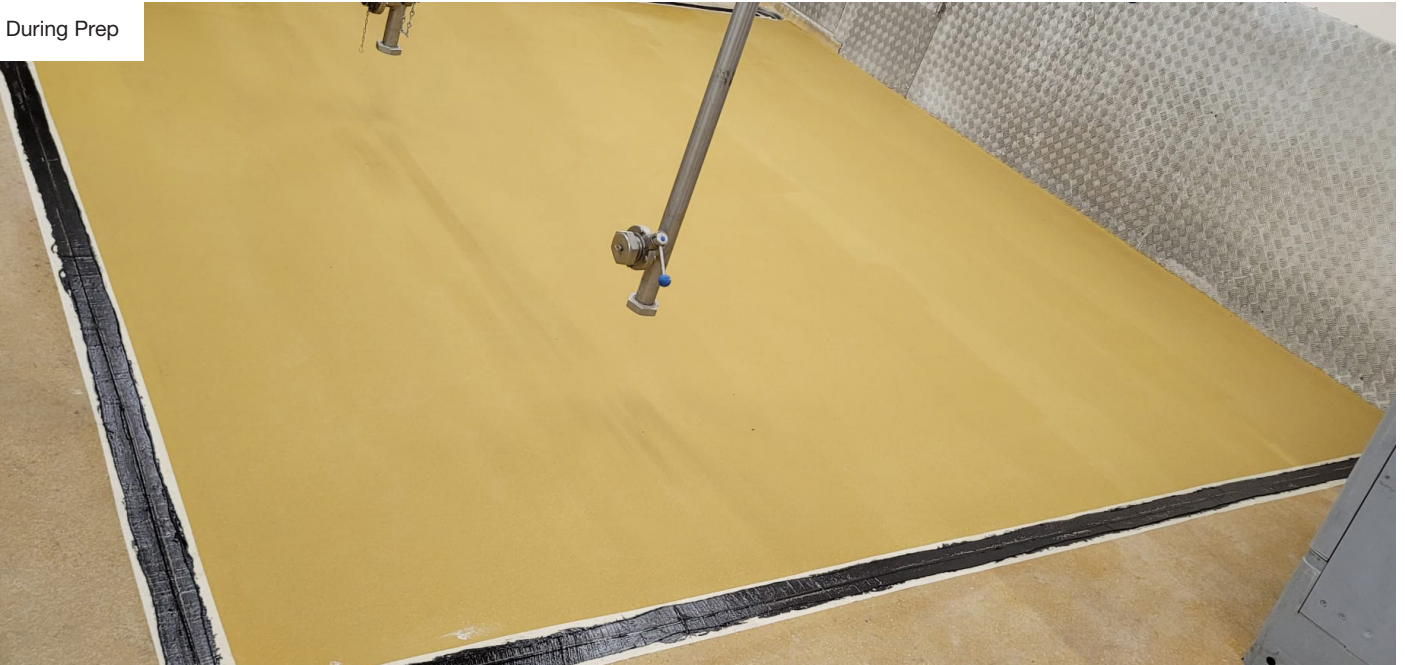
During Prep

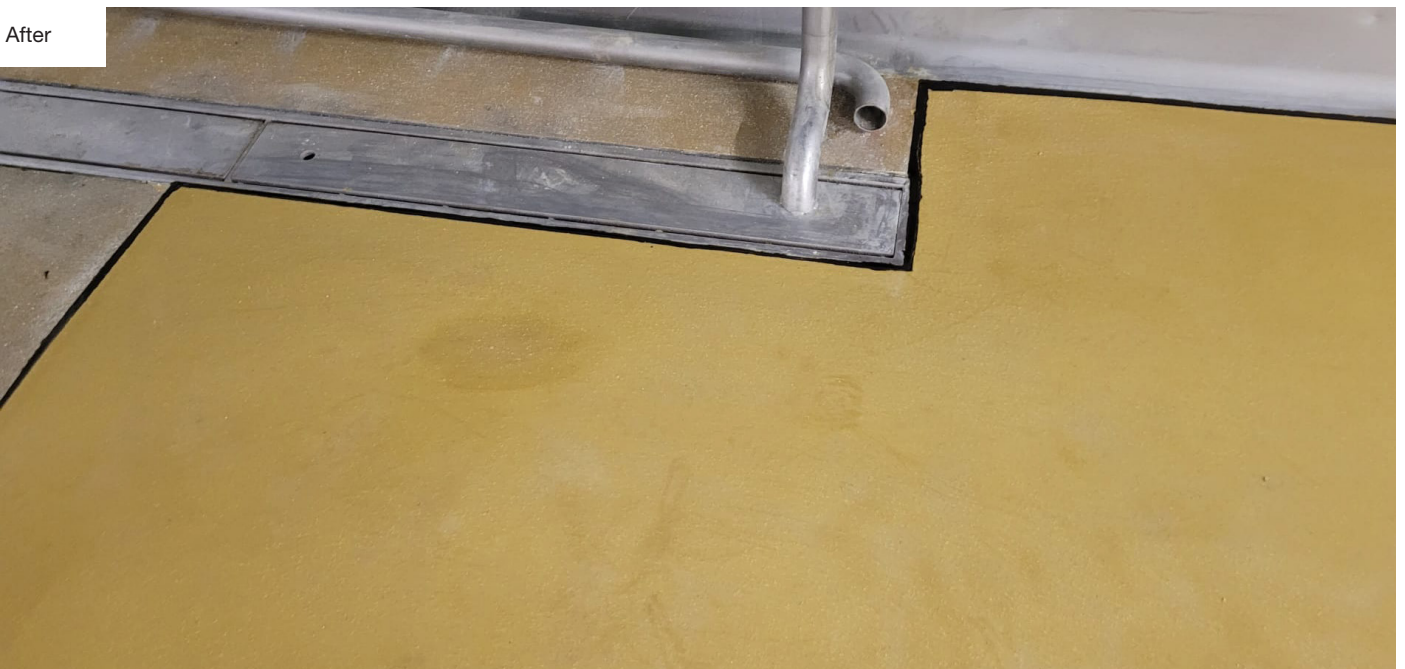
After
